**RGC Abatement/Remodel Completion
Summary of Work**

**Prepared by Baer Engineering and
Environmental Consulting, Inc.
Austin, Texas**

September 30, 2005

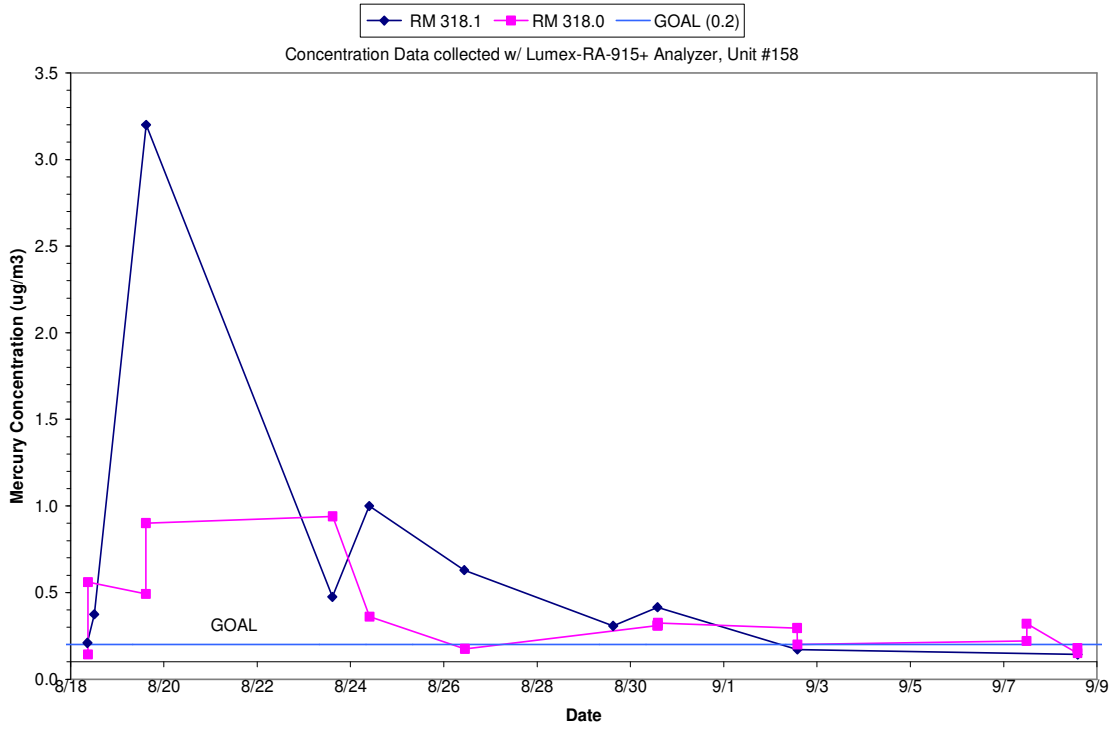
Breathing Zone Concentrations in Lab and Chemical Storage Rooms

Monitoring of the three rooms for mercury vapors was initiated after completion of initial maintenance efforts that included removal of shelving units and a small lab bench but prior to starting lead and asbestos abatement work. Levels just above the MRL were measured initially, due to the level of room disturbance that had already occurred. Mercury vapor concentrations further increased above the MRL inside the containment during abatement. The highest concentration measured inside the containment was 3.2 micrograms per cubic meter, which is the same as 0.0032 milligrams per cubic meter. Mercury vapor concentrations in the rooms rapidly decreased once the flooring materials were removed and a mercury cleaning solution was applied to targeted floor areas. Within a few days, mercury vapor levels inside Rooms 318 and 318.1 were reduced to below the MRL. All measurements in the hallways adjacent to the contained work area during the abatement and cleaning indicated that mercury concentrations remained below the MRL.

The attached chart is a chronological summary of the measurements for mercury vapor by The RETEC Group using a Lumex Mercury Vapor Monitor. Note that mercury vapor concentrations inside the containment initially increased and then steadily decreased as our work progressed. Also note that none of the hallway measurements exceeded the MRL.
