A METHOD FOR DISTINGUISHING BETWEEN  
PREHISTORIC AND RECENT  
WATER AND SOIL CONTROL FEATURES

WILLIAM E. DOOLITTLE

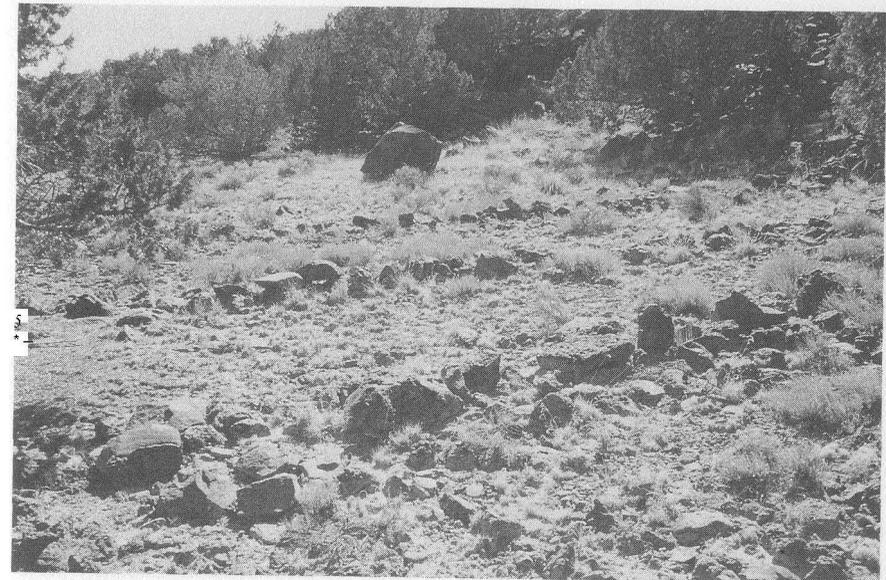
**Figure 1.** Prehistoric rock alignments at the western end of the Zuni Reservation near the New Mexico-Arizona border. Note (1) the materials used in construction are identical to those on the surrounding slope, (2) the single course construction, (3) the slope setting or location, and (4) the lack of sediment behind features. (Note: All photographs were taken by the senior author.)

**Courses.** Some water and soil control features consist of nothing more than a simple row of rocks one course high and wide (Figure 1). Others are comprised of rocks layered in multiple courses (Figures 2 and 3). Typically, single course features involve rocks the size of basketballs or greater, whereas features with multiple courses frequently incorporate rocks of virtually any size.

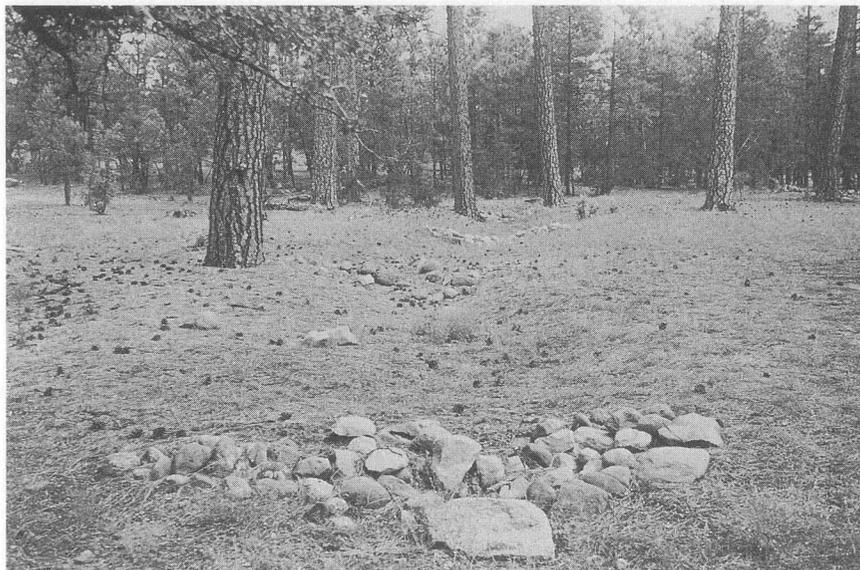
**Figure 2.** Rock alignments constructed in 1984 in the Pueblo Creek Campground, Apache-Sitgreaves National Forest, New Mexico. These features are located within 100 m of a Pueblo room block. Note (1) the difference between the rock used in construction and the surrounding slopes, (2) the multiple course construction, (3) that the one in the foreground appears to have been built by simply dumping rocks on the surface, (4) that they are set in an unincised channel, and (5) the lack of breaching.

**Material Source.** Rocks used in the construction of water control features come from either local or remote sources. That is, they were collected in the immediate vicinity, or in locales quite distant. For the most part, determination of the material source is quite easy. One only needs to look at a feature, and compare the materials with rocks nearby, within 100 m according to one source (Wilken 1987: 101). If they are similar, the feature was probably built with materials at hand (Figure 1). If not, materials were in all likelihood hauled in (Figure 2).

**Placement.** As is the case with consistence, the ages of multiple course features can be better approximated by observing how materials were actually placed during construction. Rocks can be placed in one of two ways. They can either be stacked or they can be dumped. Features built by stacking differ somewhat in appearance from features built by dumping. Although admittedly intuitive, the former look as if they were built with deliberation (Figures 3 and 4), while the latter often seem to have been built with little care (Figure 2).

Rock alignments located either on floodplains or across unincised channels are especially problematical in terms of determining their ages (Table 1). Such features are known to have been built during virtually every era. In the case of rock alignments on floodplains overlooking channels, many have been constructed recently in conjunction with farming activities (Doolittle 1984:129, Fig. 3), and are nearly identical to those built prehistorically and long abandoned (Doolittle 1980:334, Fig. 3). As for rock alignments across unincised channels, some were essential to cultivation prehistorically (Figure 3), and others were built recently in attempts to forestall gullyng (Figure 2).

There exists three categories of integrity. Rock alignments can be intact, side-breached, or center- or top-breached (Table 1). Those that are intact show few, if any, signs of deterioration (Figures 2 and 4). Those that are side-breached have had one end of the alignment removed from top to bottom, but with the opposite end almost intact. Features that are center-breached have one

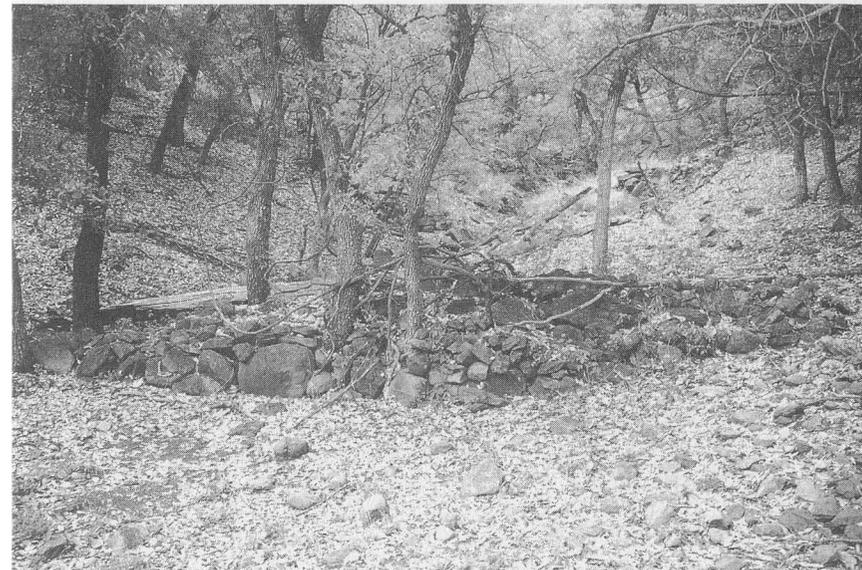
**Figure 3.** Prehistoric rock alignment at Sample Area A, Rio Gavilan, Chihuahua, Mexico (Herold 1965). Note (1) the multiple course construction, (2) the variety of rock sizes, including boulders that were probably in place before construction, (3) restacking of rocks that required some degree of care, (4) the level or flat top, (5) the setting across an unincised channel, and (6) the large, and hence old, oak trees growing through the feature.

titude of sizes (Figure 3). Others are uniform, consisting largely of rocks of one size (Figure 4).

*Elevation.* When viewed from the front, (that is, from down slope) the tops of rock features are either level (Figure 3) or dipped, slightly lower in the center than at either end (Figure 4). In terms of age (Table 1), level elevations

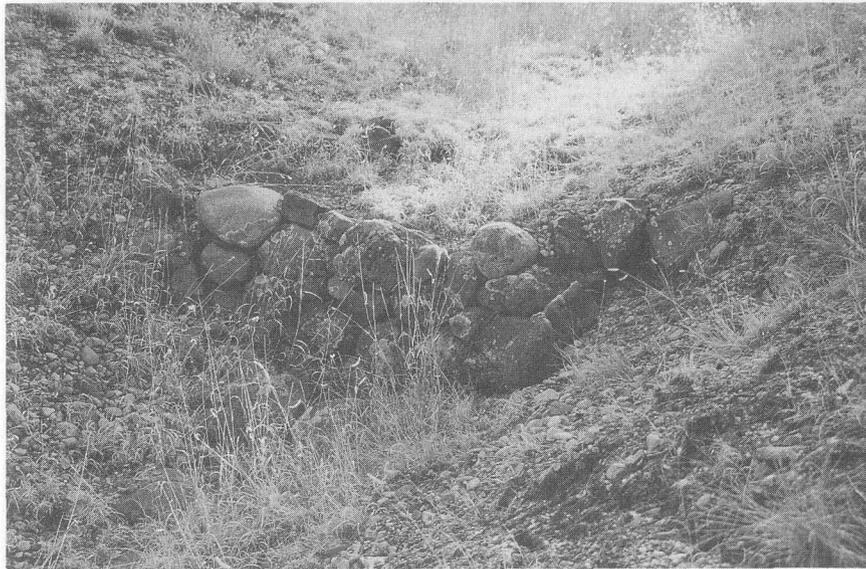
**Figure 4.** Water and soil control structure built by the Civilian Conservation Corps (CCC) in the 1930s near Mogollon, New Mexico. In addition to the multiple course construction, note (1) the uniformity in the sizes of the rocks, (2) the stacking of materials that involved a certain amount of deliberation, (3) the dipped elevation, (4) the way in which rocks were stacked in the channel, abutting the banks, (5) the lack of breaching, and (6) the sediment accumulation behind the structure.

rock structures in gullies. In some cases rock alignments were built prehistorically across unincised channels or on floodplains and later covered by sediment. Subsequent gullyng has then exposed these structures, which look at first glance much like gully plugs (Figure 6). Closer inspection reveals that rocks continue into the gully banks and under the overlying sediment. Recently constructed rock alignments in gullies about the channel banks (Figures 4 and 5).

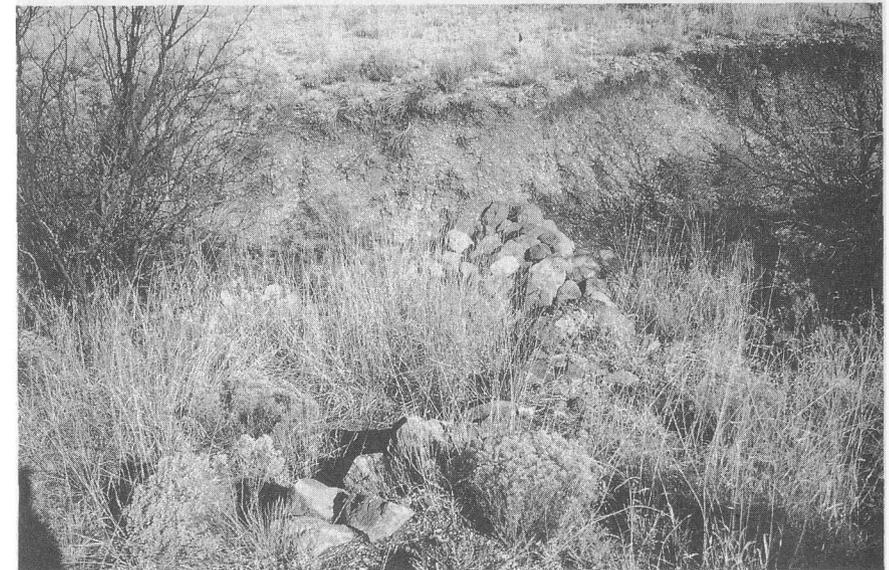
**Figure 5.** Rock structure built by the CCC in the 1930s south of Glenwood, New Mexico (Ellis 1991). Note (1) the upstream arch, (2) that the feature is set entirely within a gully, with the ends abutting the banks, and (3) the lack of sediment accumulation.

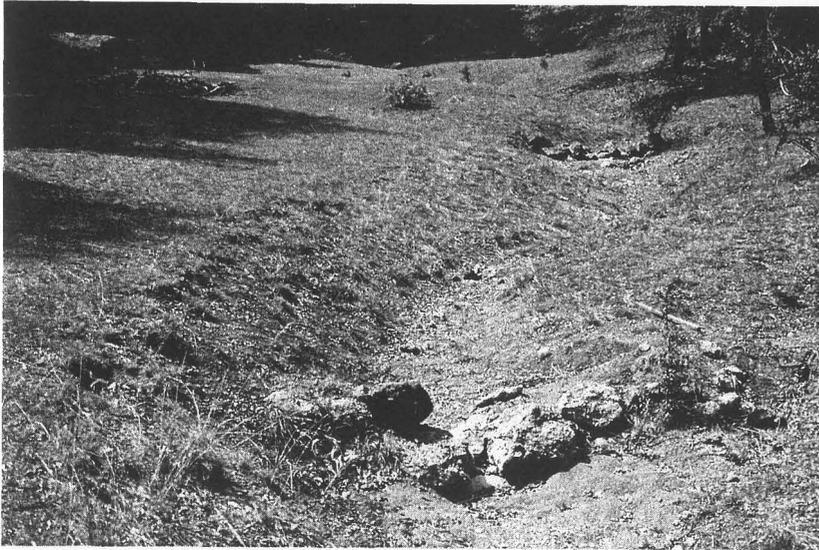
Figure 6. Upstream view of rock features in a gully near Corral Cave, Chihuahua, Mexico (Lister 1958). The alignments were built in prehistoric times on the floor of what was an unincised tributary of the Rio Piedras Verdes. They were later covered with sediment and only recently exposed by gullyng. Note that the features extend into and under the channel banks, and that center-breaching appears similar to a dipped profile.

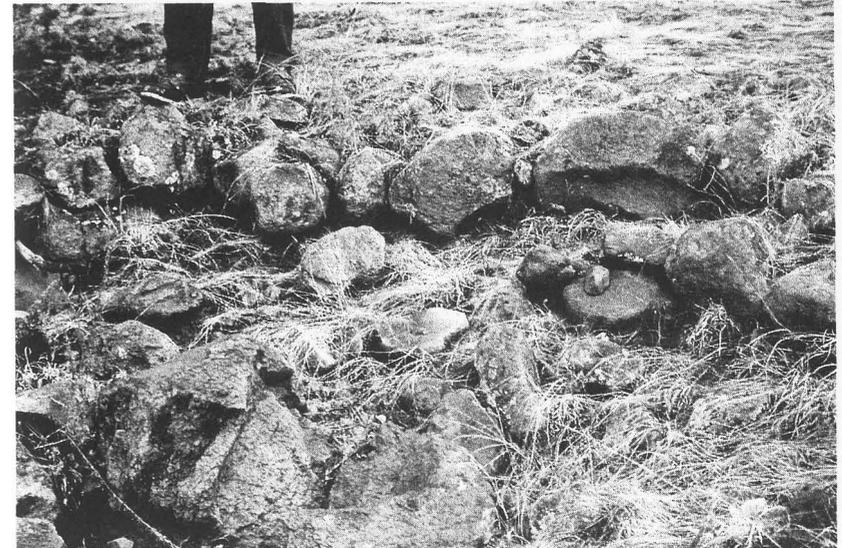
Figure 7. Close-up view of a prehistoric rock alignment at Area III of sites near Lake Roberts, north of Silver City, New Mexico (Sandor and others 1990). Note (1) that a sufficient amount of sediment has accumulated in the interstices to allow for the growth of grasses, and (2) the sediment accumulated behind the feature.

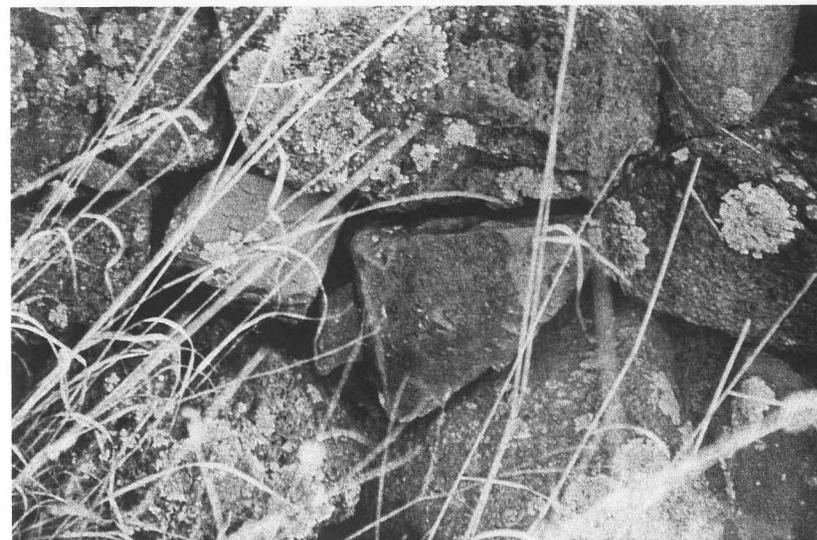
**Figure 8.** Close-up view of the feature shown in Figure 4. Note that the interstices remain free of sediment.

**Interstices.** The spaces between rocks, interstices, can either contain sediment or be relatively free of it. The degree to which interstices have become filled with sediment is nearly always chronologically diagnostic, as the amount of filling seems to be a function of time. Generally speaking, the older the feature, the more sediment that has accumulated between the rocks (Table 1). Prehistoric rock alignments tend to have a great deal of sediment filling the interstices (Figure 7), historic ones have some, and recent ones have very little if any such sediment (Figure 8).
